Professional Inspection Report

417 E Benton
Iowa City, IA 52240

General Information

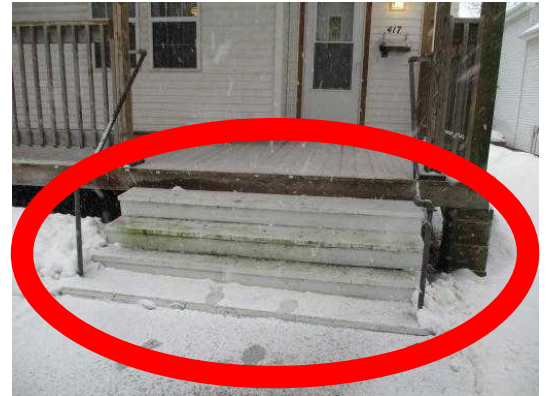
The front entry steps were not uniform and therefore rated non functional as a safety hazard. It is recommended that all riser heights be uniform (within 3/8") for safety. Recommend new steps be installed conforming to current standards.

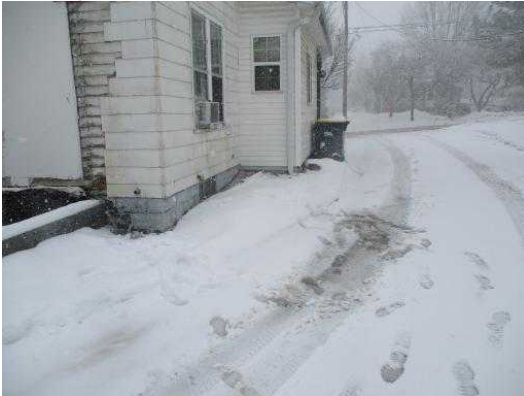
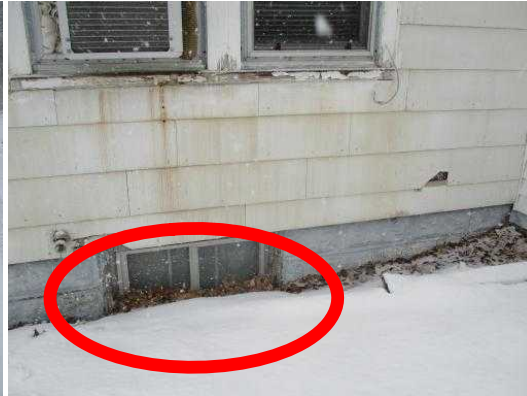
Accumulated snow greatly limited the view for inspection. Based on the visible surface, there were indication the drainage improvement may be necessary along the East side of the house. It is recommended that at least 6" of clearance be maintained below basement window openings, and that the grade fall a minimum of 6" within the first 10' of the foundation. When this type of fall can not be established, the use of drains or swales should be utilized to ensure proper drainage away from the structure. The grade surrounding the basement window well, South of the rear deck, slope towards the foundation, and there were indications that drainage into the window well was occurring where the well was separated from the foundation. The grade directly along the East and North sides of the dwelling was very flat and did not slope away from the foundation. Recommend corrective measures be completed to establish proper clearances and slope away from the foundation. To obtain a proposal / estimate, recommend consult a qualified contractor.

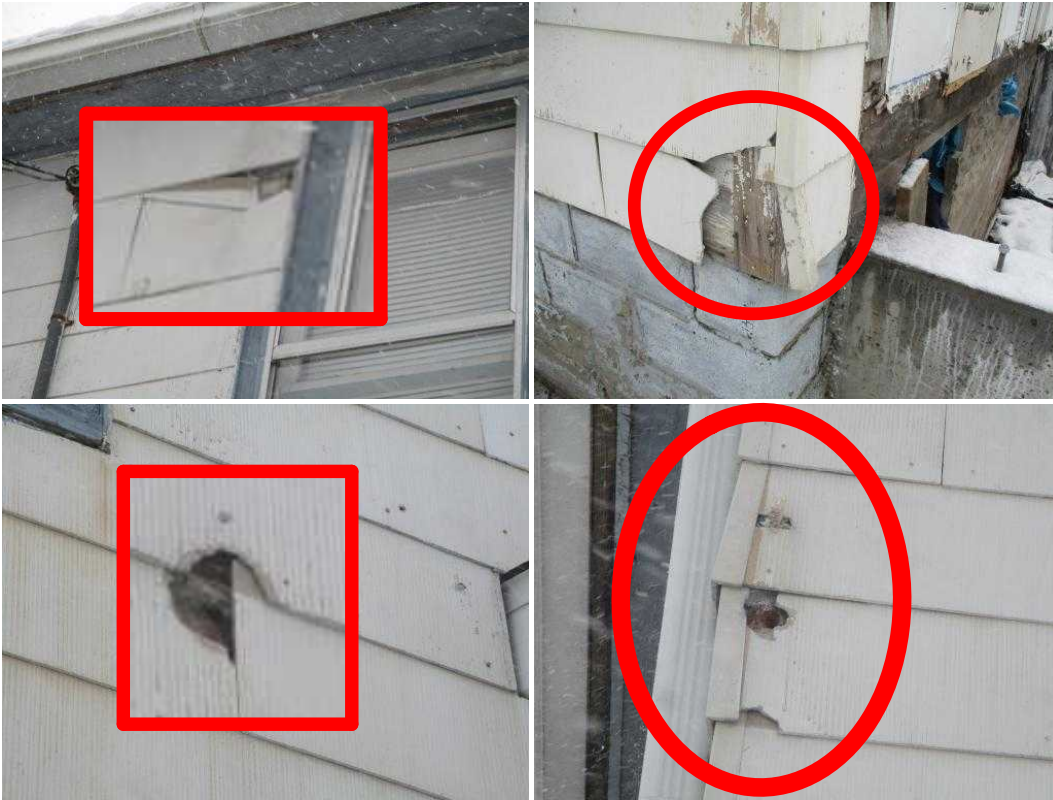
Dwelling Exterior Siding

2. Priority Item **Material:** Transite / Cement Asbestos
The siding at the West, South, and SE areas of the dwelling exterior appeared to be a cement asbestos tile. This type of siding may contain asbestos fibers. The presence of asbestos can only be confirmed with laboratory testing. Asbestos inspection and or testing is beyond the scope of this inspection. In general, this type of siding does not cause a health hazard if in tact and left undisturbed (non friable). Several cracked and or damaged tiles were noted throughout the dwelling which is not uncommon, but repairs are recommended to provide proper weather protection. Recommend further research proper precautions that should be exercised with this type of siding. The local health department may be a source of such information. General recommendations are for repairs to be completed by a properly trained / certified professional.

Loose paint was also noted during the inspection. Based upon the age of the dwelling/garage it is possible that lead paint exists. Identification or evaluation of environmental concerns such as lead paint are beyond the scope of this inspection. Recommend contact the local Department of Health for guidelines / precautions or consult a qualified contractor as necessary in preparing / painting surfaces which may contain lead paint for added safety.

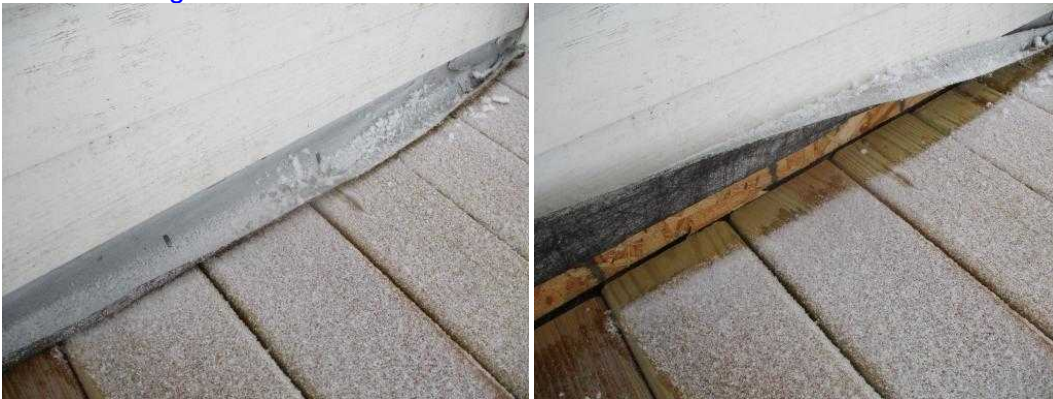
The weather resistant barrier extended out from the bottom of the siding and overtop of the porch floor. Recommend permanent flashing be installed where the floor structure of the porch is attached to the house. All components should be installed in a shingle fashion extending back to the exterior.

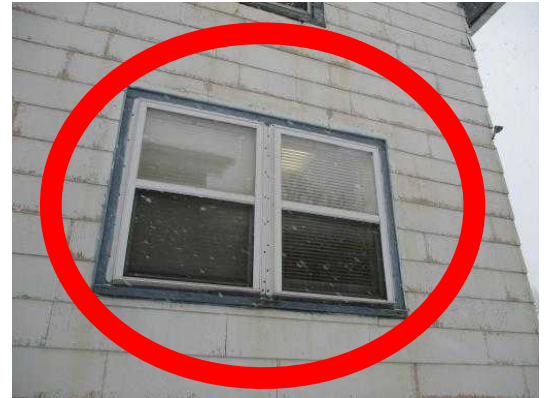
No flashing, trim, or cladding was installed around the perimeter of the kitchen window leaving the nailing flange exposed. This leaves the window openings more subject to water infiltration issues. Recommend corrective measures be completed to provide proper weather protection around the perimeter of the windows. Installation of an adhesive window flashing tape and trim or other cladding material may be an option.

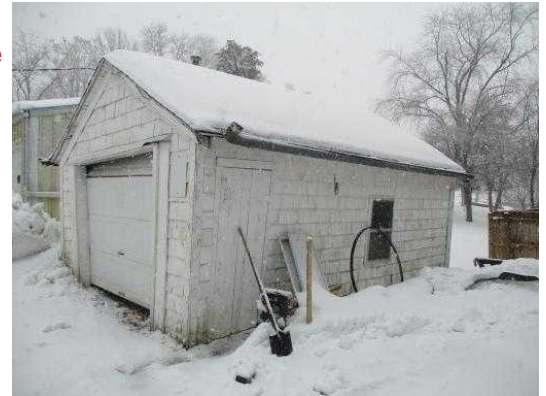
In general, the detached garage was in a decrepit / damage state of condition, and no further evaluation was completed. Recommend consult with a qualified contractor to obtain a proposal for repair, demolition / removal, and or replacement.

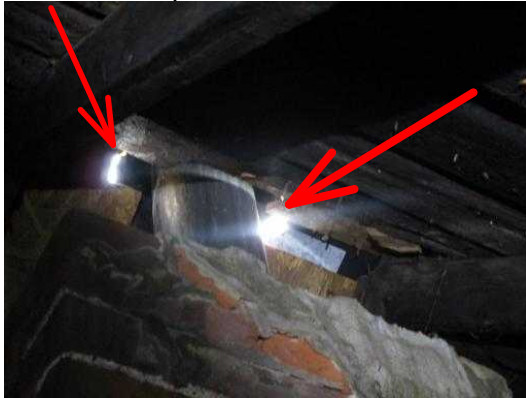
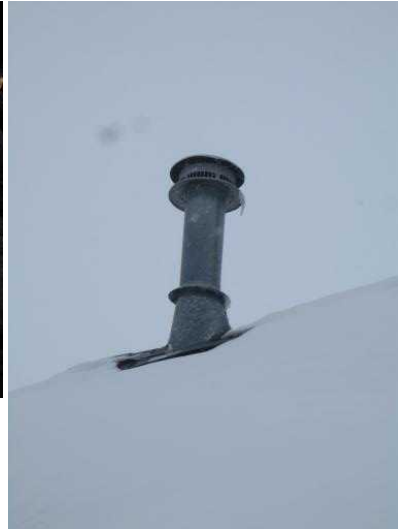
Daylight was visible where the gas vent passed through the roof. The roof area was not accessible during the inspection. Recommend further evaluation and or corrective measures completed to ensure the gas vent penetration is properly flashed and sealed to provide proper weather protection.

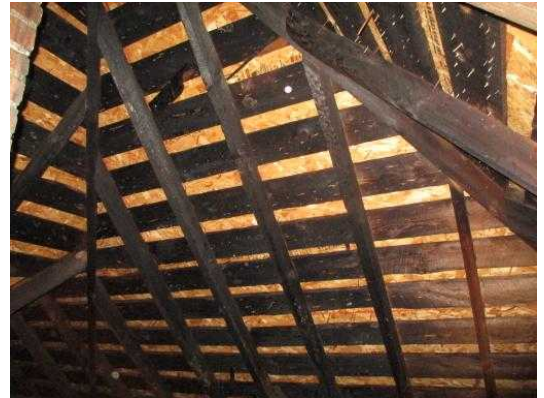
Fire damage was noted at the older visible roof structure at the South side of the attic. Structural evaluation of fire damaged components is beyond the scope of this inspection. No structural repairs or bracing had been installed. Installation of sister rafters alongside of the damaged rafters should be considered to help ensure structural integrity. For further evaluation and or to obtain a proposal and estimate of cost, recommend consult a qualified carpenter / contractor.

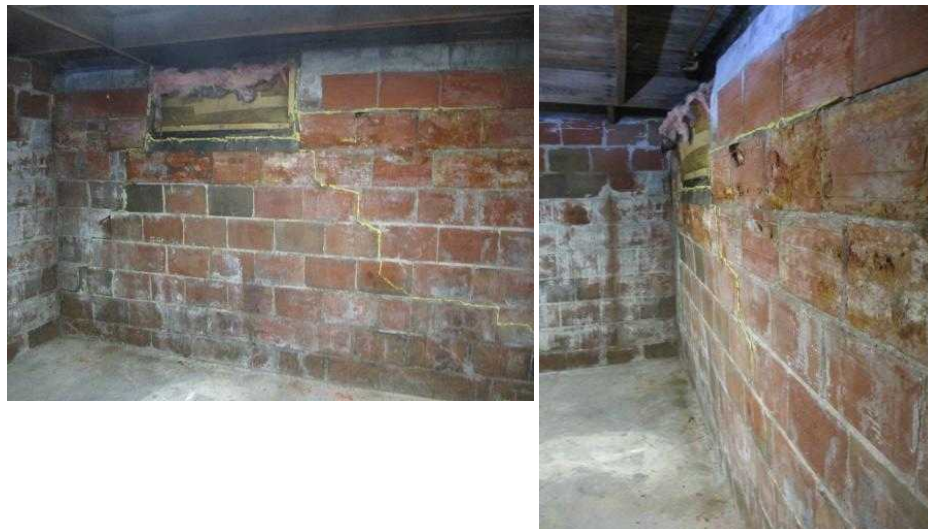
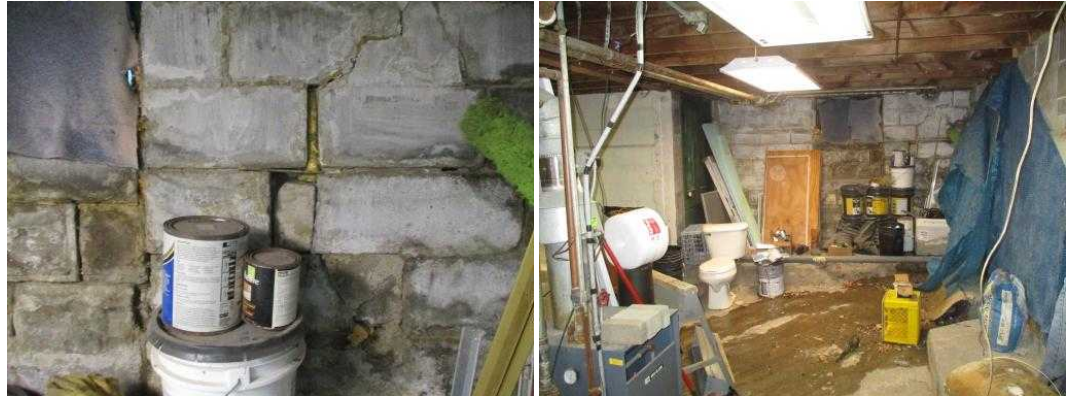
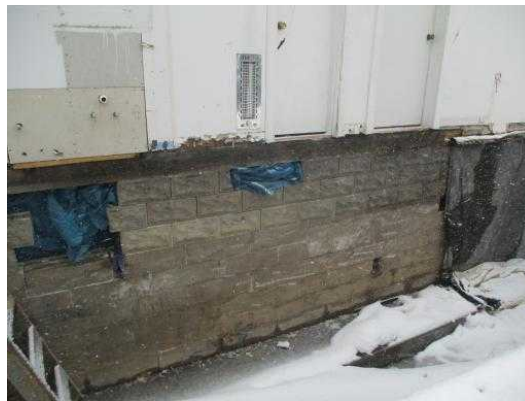
Substantial cracks and inward displacement was noted in the East clay tile block foundation wall, inside of the basement's NE room. Damaged block, cracks, and missing mortar was also noted in the East concrete block wall at the SE corner of the basement. Recommend a qualified foundation repair contractor or structural engineer complete further evaluation and provide a proposal and estimate of corrective action. Installation of interior wall bracing can be an option to help stabilize the foundation, but if the displacement / movement is never enough, replacement of the foundation wall can be necessary. General recommendations are for block / crack and tuck pointing repairs also be completed as necessary. Corrective measures may also be necessary at the exterior to help ensure storm water is properly drained away from the foundation. Accumulated snow and drifts greatly limited the view at the exterior during the inspection.

Openings had been created in the South concrete block foundation wall, that appeared to be related to the addition that was in process at the on the South end of the house. Recommend all foundation wall openings be repaired along with the completion of the addition.

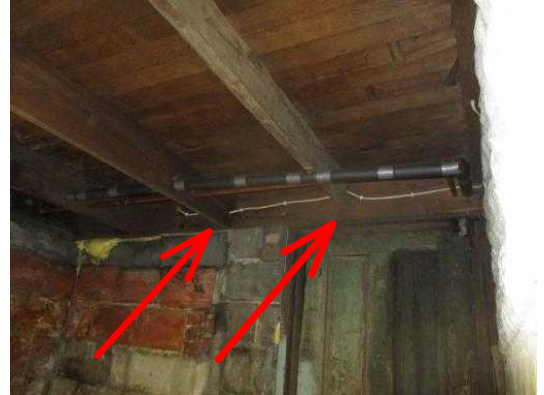
Recommend joist hangers be installed at the South end of the floor joists in the basement's NE room.

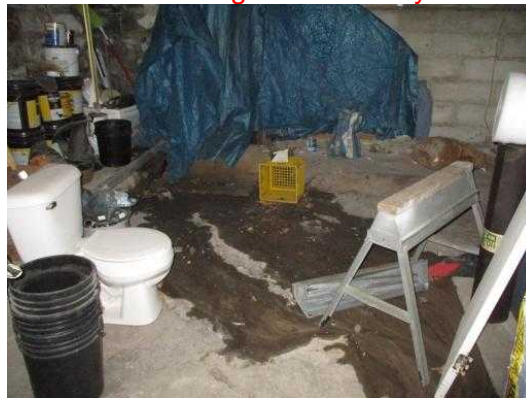
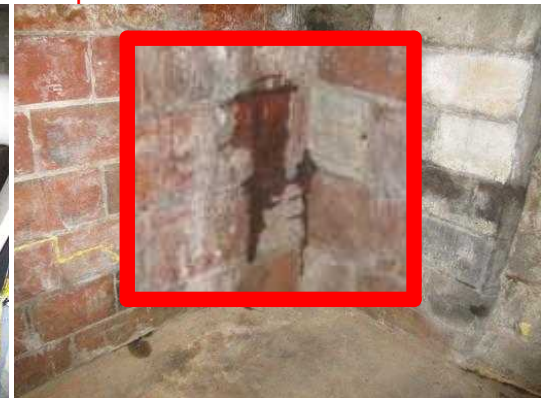
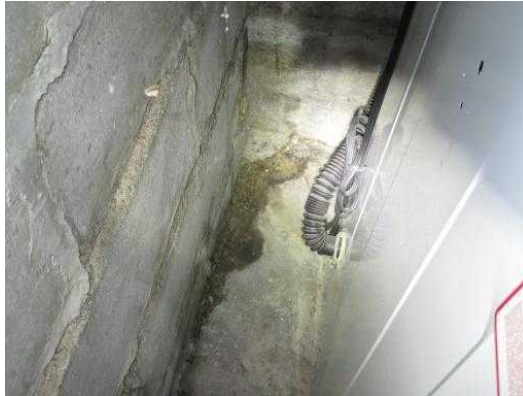
Significant water infiltration issues were observed in the basement during the inspection, most of which appeared to be related to rear addition having been removed. Signs of seepage were also noted in the SE corner of the basement's NE room, and behind the washing machine. Recommend corrective measures be completed as necessary to ensure exterior storm water is properly managed and channeled away from the foundation. See related grade, gutter, and downspout comments (Grounds and roofing sections). It was reported that the basement would be used regularly. If a completely dry basement is expected, recommend further evaluation be completed by a qualified basement water proofing contractor to obtain a proposal and estimate for guaranteed dry basement repairs.

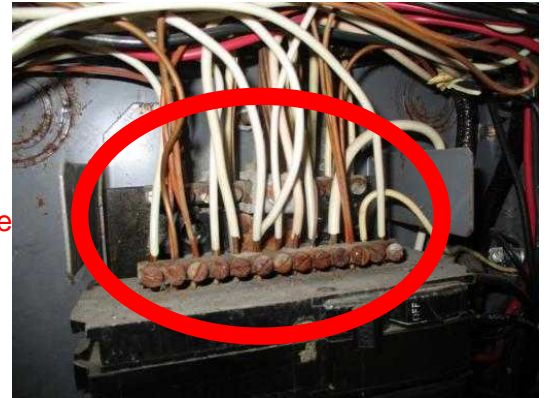
The electrical circuits were not labeled. Recommend all circuits be accurately labeled for easy identification and safety.

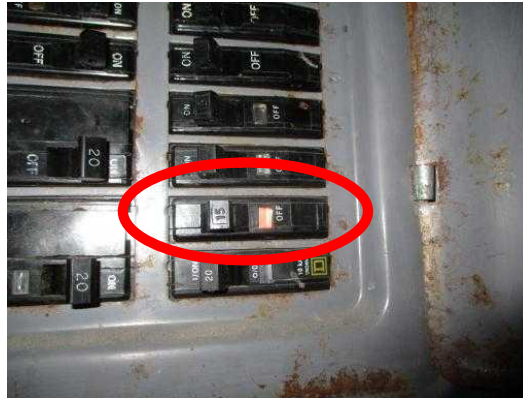
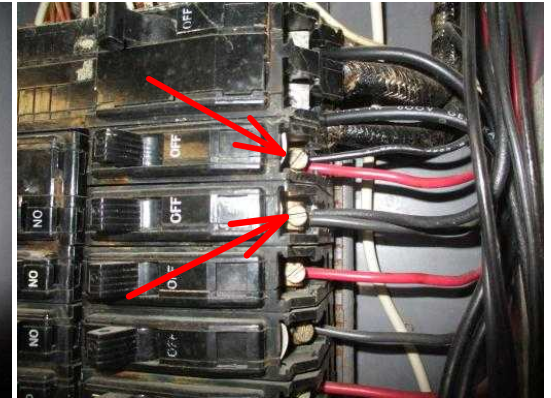
There were 2 wires attached to two of the single pole breaker terminals within this electrical panel. Installation of more than one wire per terminal can result in a loose wire connection, improper electrical performance, over heating and considered a safety issue. Recommend a licensed electrician complete repairs to correct this condition for improved safety.

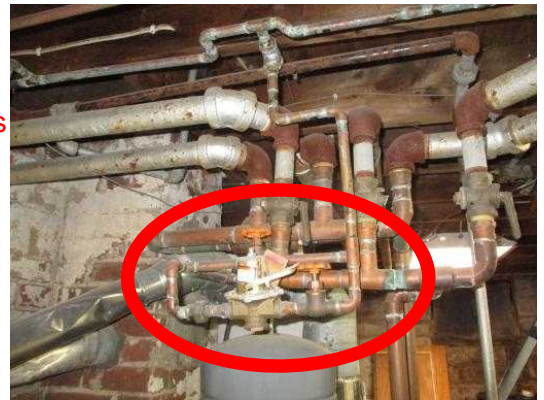
No visible back flow prevention device was noted in place between the dwelling's domestic water supply and the hot water boiler system. While the lack of backflow prevention is not uncommon in older systems and or in some locations, it is recommended to prevent potential cross connection for health and safety. Backflow requirements can vary between locations. For any further information, recommend consult the local authority having jurisdiction or the water supply utility company. General recommendations are for a licensed plumber to install a backflow prevention device for health / safety.

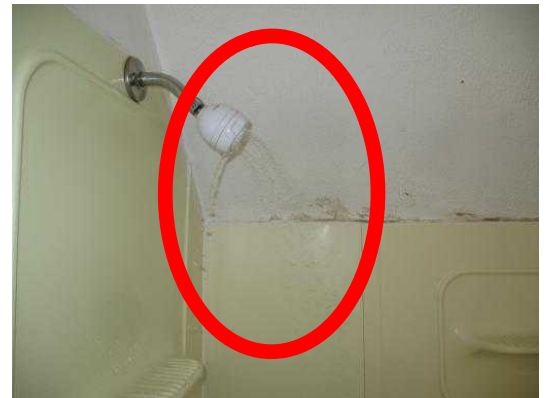
Very poor water pressure was noted from the 2nd floor bathroom shower when multiple plumbing fixtures were operated simultaneously (especially flushing the toilet). Recommend further evaluation be completed by a licensed plumber to obtain a proposal for corrective measures.

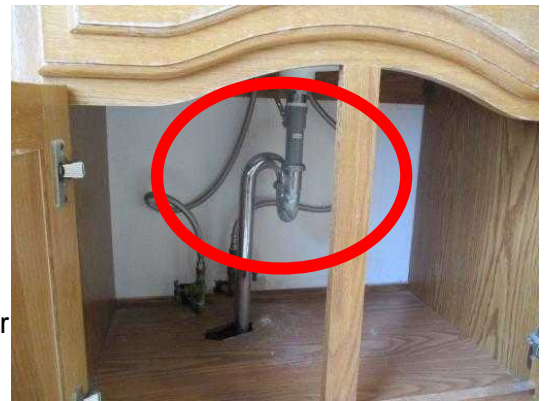
An S trap was noted below the bathroom sink. This is an older and un-vented type of drain trap that is more prone to siphoning and dry trap conditions that can lead to the escape of sewer gases. General recommendations are to make improvements to help prevent these conditions. Installation of a properly vented P trap is recommended. The use of an air admittance valve may be a retrofit option to provide a drain ventilation source if installation of a proper exterior vent is cost prohibitive (however these types of interior devices are not allowed by some authorities having jurisdiction).

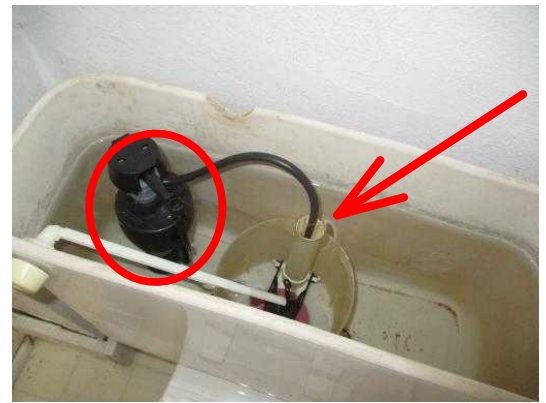
The toilet was loose and the tank refill ran on beyond the overflow. Recommend repairs be completed by a licensed plumber and leak free and proper flush / fill operation verified.

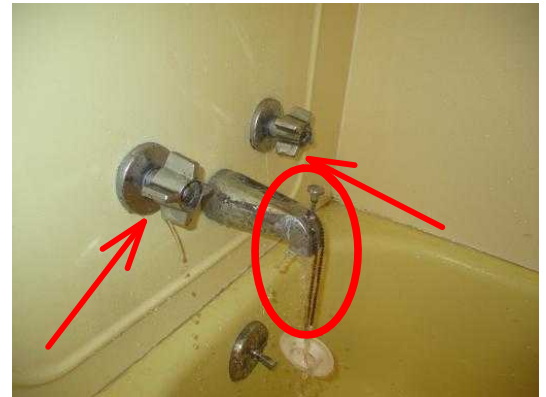
Leakage was noted from the hot and cold water supply valves when the shower was operating. The diverter valve was also stuck and leaking. Recommend repairs be completed by a licensed plumber and leak free valve and proper diverter operation verified.

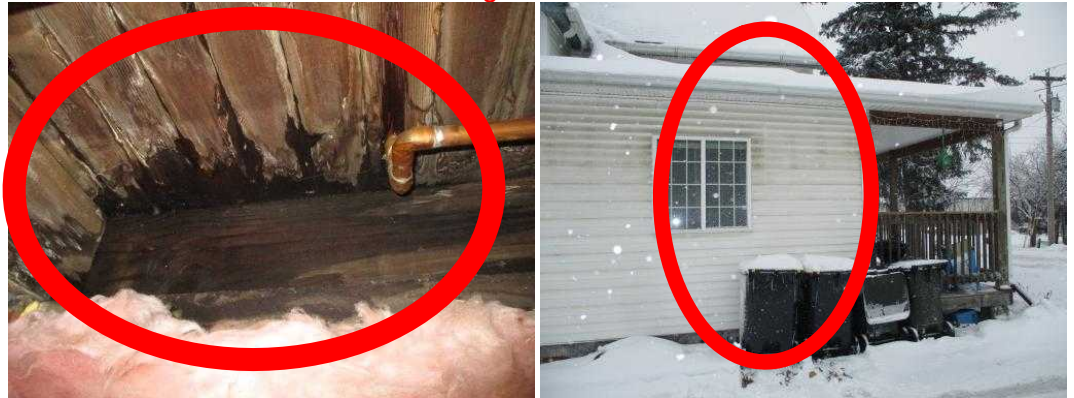
The subfloor was wet as viewed from the NE corner of the basement, at the area below and just North of the hydronic baseboard unit. No obvious sources of leakage could be identified. It is possible that an ice dam or other roofing issue exists and leakage is traveling down the wall cavity and showing up on the floor of the NE room. Recommend further investigation be completed by a qualified contractor to identify the source of leakage and repairs completed. Recommend any moisture damaged components be replaced and corrective measures completed to eliminate the cause of the leakage.

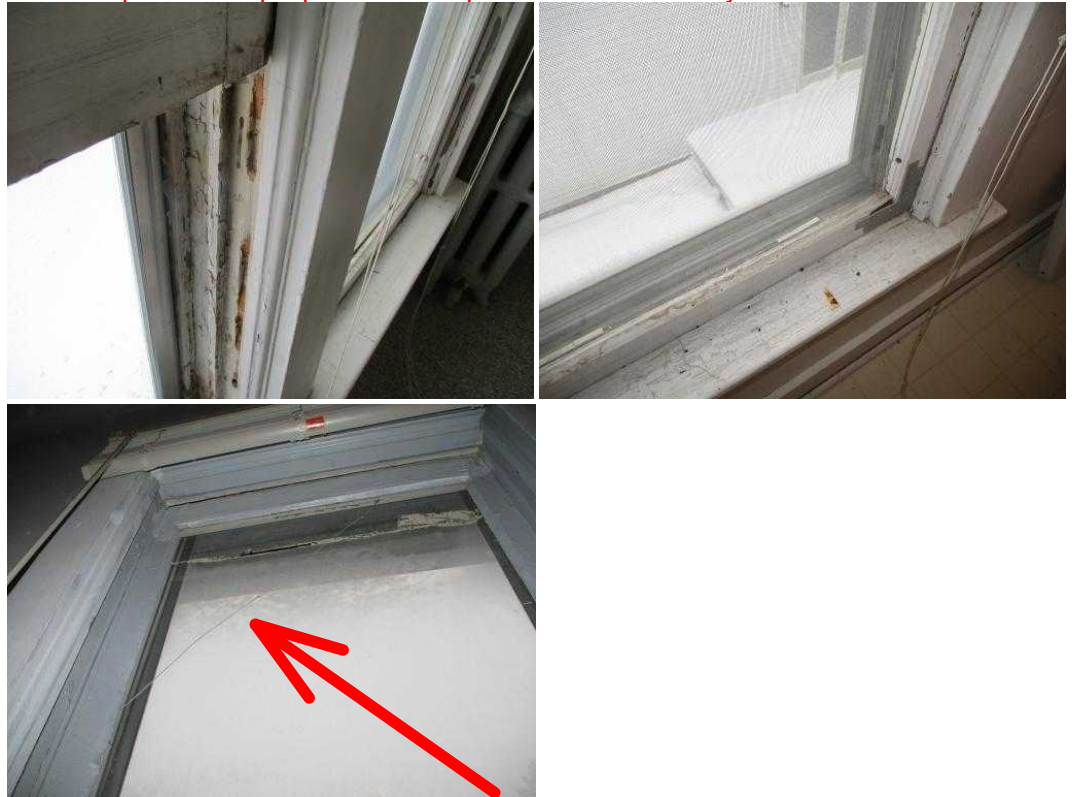
Cracked window panes were noted at the 2nd floor stairway. Recommend cracked glass panes be replaced for proper weather protection and safety.

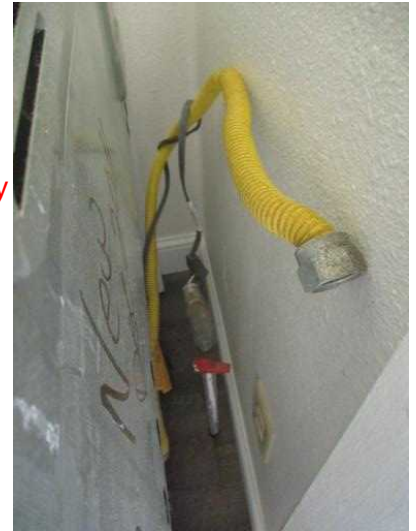
The kitchen range was not installed / connected and could not be operated at the time of the inspection. Recommend installation be completed and proper operation verified. General recommendations are to cap the gas line while the appliance is not connected / actively used, for safety.
