Professional Inspection Report

417 E Benton
Iowa City, IA 52240

General Information

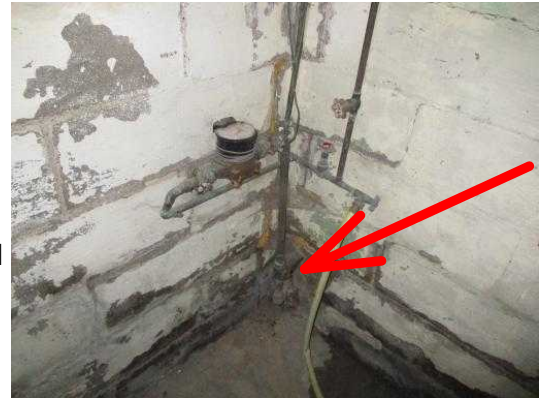
The incoming water line was older galvanized piping as viewed at the area where it enters through the foundation. The underground water piping is not visible for inspection. Overtime underground galvanized water piping can rust and or develop a mineral buildup and eventually could require replacement due to leakage and or a reduction of water pressure.

The dwelling's main water shut off valve is not operated during the inspection. A photo of the main water shut off valve(s) was included for reference.

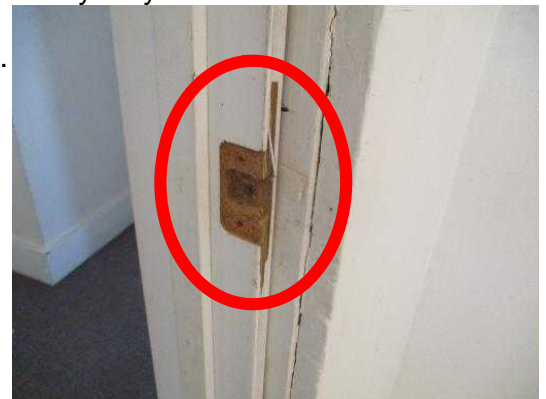
The strike plate was missing at the 2nd floor bathroom door. Recommend hardware be installed where missing. Multiple doors were in need of maintenance hardware adjustment to latch / lock properly.

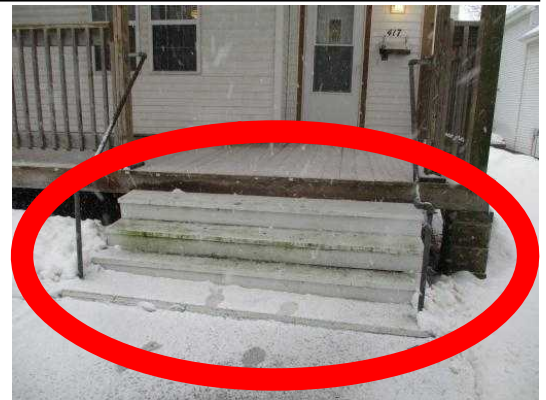
- 2. Stairways:** The front entry steps were not uniform and therefore rated non functional as a safety hazard. It is recommended that all riser heights be uniform (within 3/8") for safety. Recommend new steps be installed conforming to current standards.

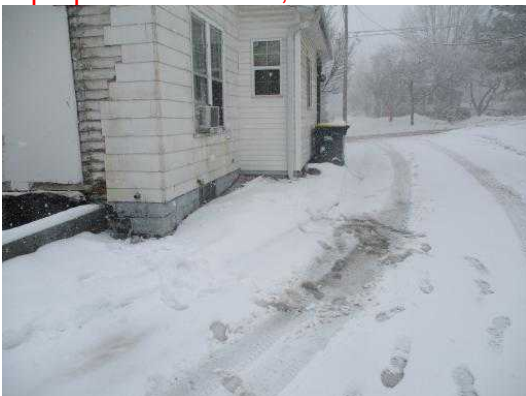
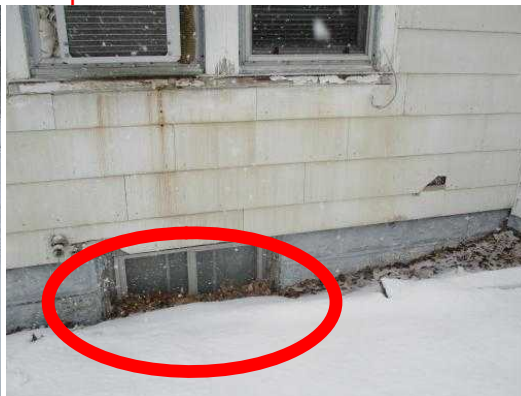
- 3. Grading:** Accumulated snow greatly limited the view for inspection. Based on the visible surface, there were indication the drainage improvement may be necessary along the East side of the house. It is recommended that at least 6" of clearance be maintained below basement window openings, and that the grade fall a minimum of 6" within the first 10' of the foundation. When this type of fall can not be established, the use of drains or swales should be utilized to ensure proper drainage away from the structure. The grade surrounding the basement window well, South of the rear deck, slope towards the foundation, and there were indications that drainage into the window well was occurring where the well was separated from the foundation. The grade directly along the East and North sides of the dwelling was very flat and did not slope away from the foundation. Recommend corrective measures be completed to establish proper clearances and slope away from the foundation. To obtain a proposal / estimate, recommend consult a qualified contractor.

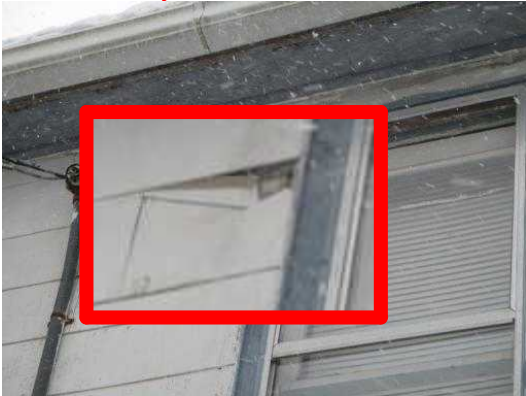
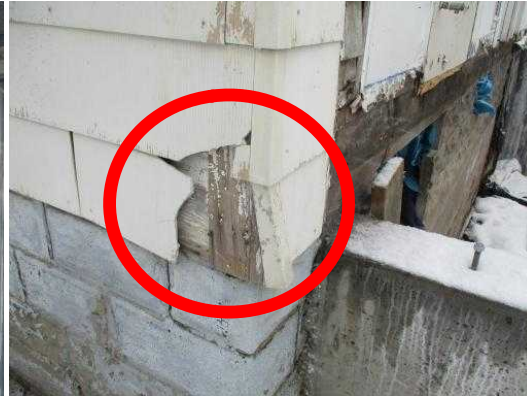
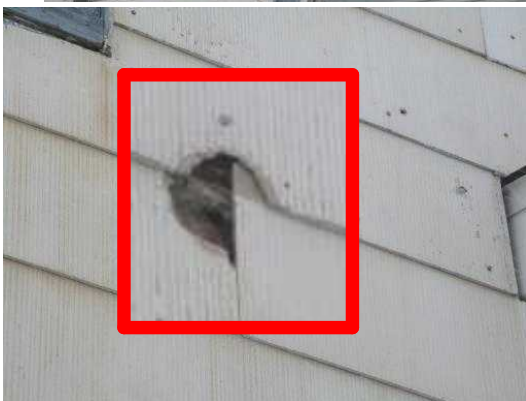
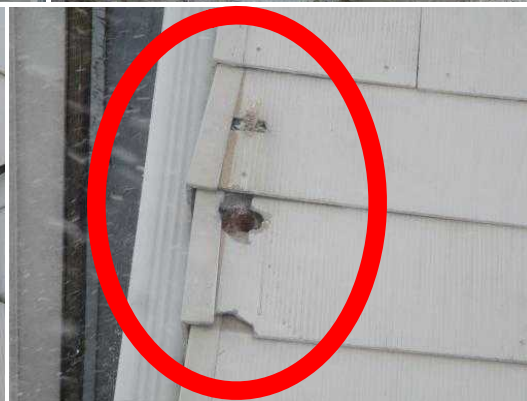
4. **Dwelling Exterior Siding Material:** Transite / Cement Asbestos The siding at the West, South, and SE areas of the dwelling exterior appeared to be a cement asbestos tile. This type of siding may contain asbestos fibers. The presence of asbestos can only be confirmed with laboratory testing. Asbestos inspection and or testing is beyond the scope of this inspection. In general, this type of siding does not cause a health hazard if in tact and left undisturbed (non friable). Several cracked and or damaged tiles were noted throughout the dwelling which is not uncommon, but repairs are recommended to provide proper weather protection. Recommend further research proper precautions that should be exercised with this type of siding. The local health department may be a source of such information. General recommendations are for repairs to be completed by a properly trained / certified professional.

Loose paint was also noted during the inspection. Based upon the age of the dwelling/garage it is possible that lead paint exists. Identification or evaluation of environmental concerns such as lead paint are beyond the scope of this inspection. Recommend contact the local Department of Health for guidelines / precautions or consult a qualified contractor as necessary in preparing / painting surfaces which may contain lead paint for added safety.

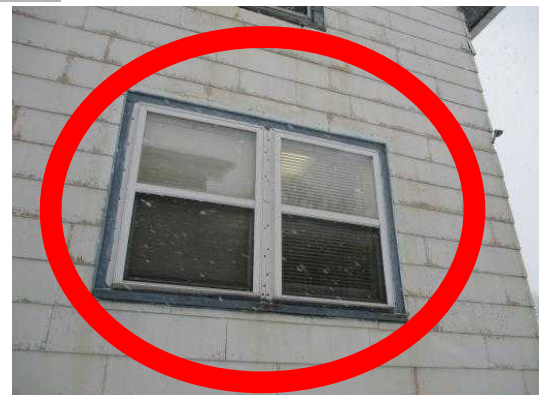
5. **Exterior Windows / Trim:** No flashing, trim, or cladding was installed around the perimeter of the kitchen window leaving the nailing flange exposed. This leaves the window openings more subject to water infiltration issues. Recommend corrective measures be completed to provide proper weather protection around the perimeter of the windows. Installation of an adhesive window flashing tape and trim or other cladding material may be an option.

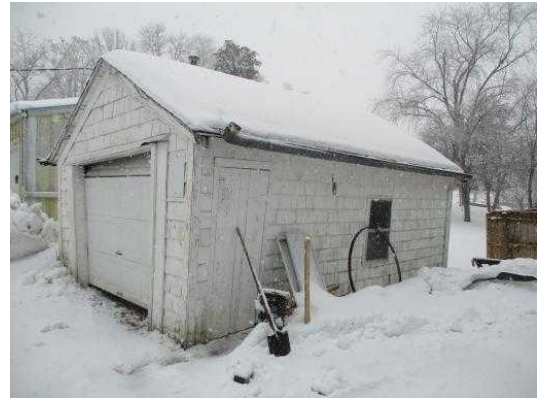
6. **Garage:** In general, the detached garage was in a decrepit / damage state of condition, and no further evaluation was completed. Recommend consult with a qualified contractor to obtain a proposal for repair, demolition / removal, and or replacement.

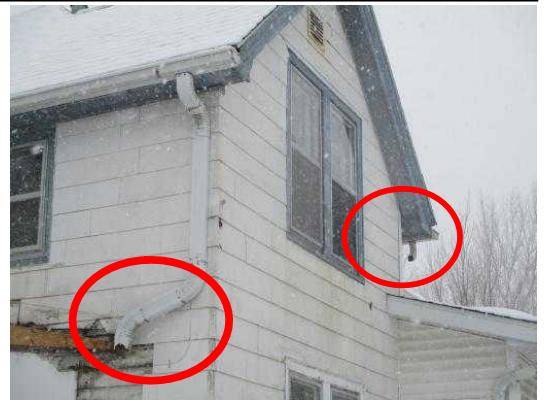
7. **Downspouts:** The downspout at the NE and SE corner of the dwelling were not extended to the ground. Recommend installation be completed to properly manage and channel storm water away from the structure / foundation.

Downspout extensions should be arranged and maintained to channel drainage water away from the foundation walls which promotes good drainage and helps to reduce the potential of ground water infiltration issues within the basement.

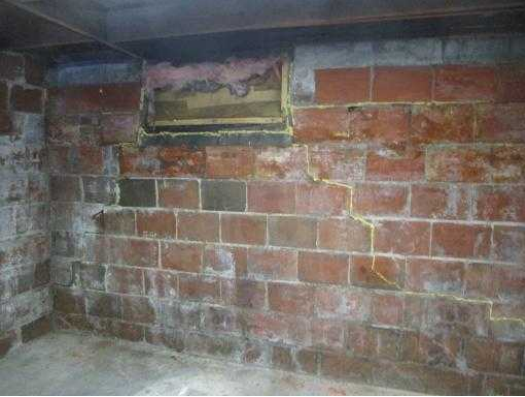
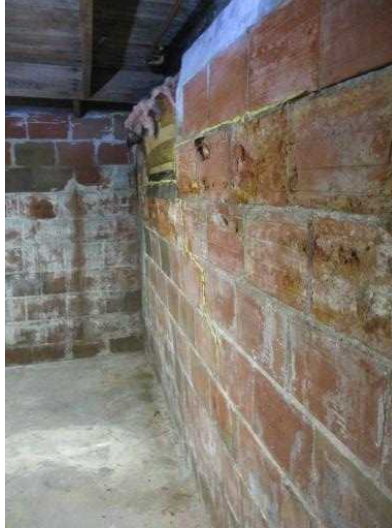
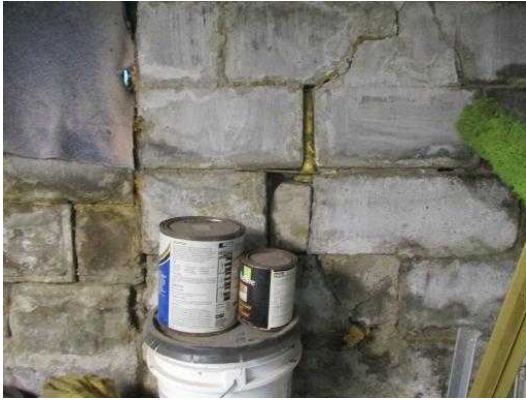
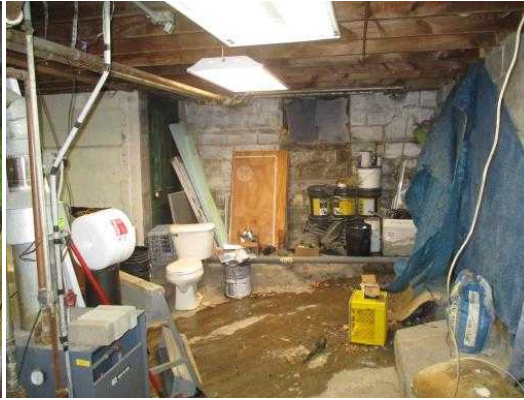
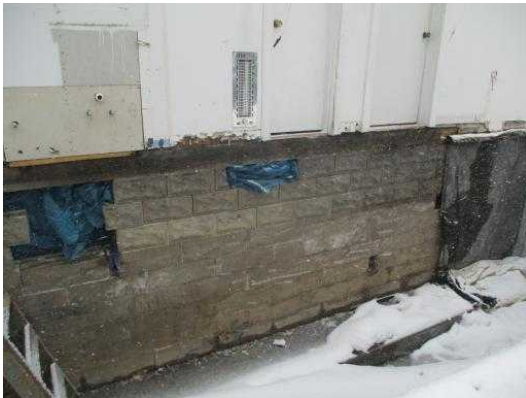
8. **Interior Foundation:** Substantial cracks and inward displacement was noted in the East clay tile block foundation wall, inside of the basement's NE room. Damaged block, cracks, and missing mortar was also noted in the East concrete block wall at the SE corner of the basement. Recommend a qualified foundation repair contractor or structural engineer complete further evaluation and provide a proposal and estimate of corrective action. Installation of interior wall bracing can be an option to help stabilize the foundation, but if the displacement / movement is never enough, replacement of the foundation wall can be necessary. General recommendations are for block / crack and tuck pointing repairs also be completed as necessary. Corrective measures may also be necessary at the exterior to help ensure storm water is properly drained away from the foundation. Accumulated snow and drifts greatly limited the view at the exterior during the inspection.

Openings had been created in the South concrete block foundation wall, that appeared to be related to the addition that was in process at the on the South end of the house. Recommend all foundation wall openings be repaired along with the completion of the addition.

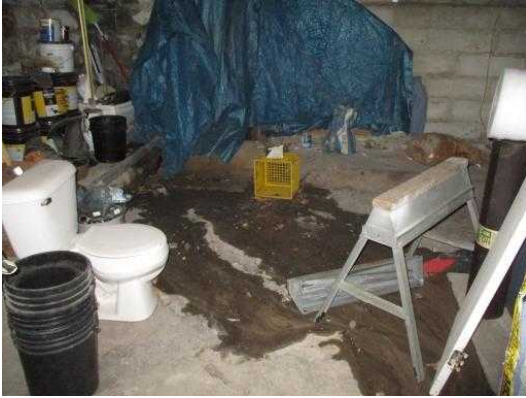
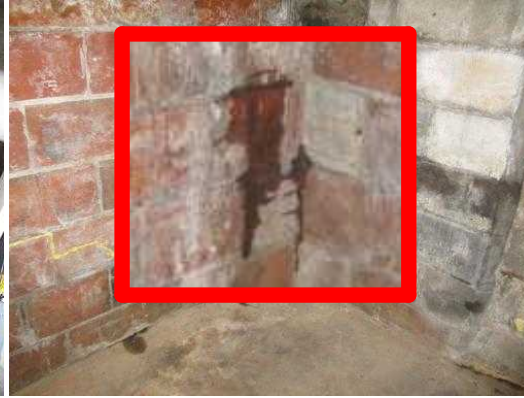
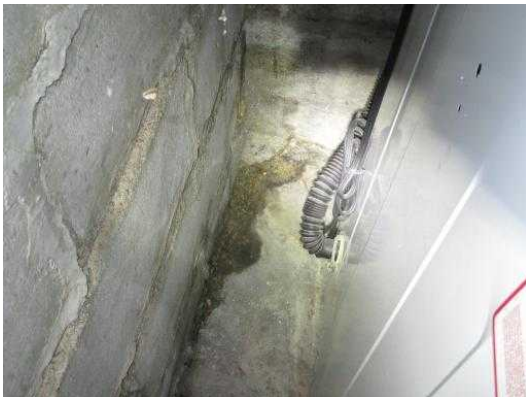
- 9. Evidence of Moisture:** Significant water infiltration issues were observed in the basement during the inspection, most of which appeared to be related to rear addition having been removed. Signs of seepage were also noted in the SE corner of the basement's NE room, and behind the washing machine. Recommend corrective measures be completed as necessary to ensure exterior storm water is properly managed and channeled away from the

foundation. See related grade, gutter, and downspout comments (Grounds and roofing sections). It was reported that the basement would be used regularly. If a completely dry basement is expected, recommend further evaluation be completed by a qualified basement water proofing contractor to obtain a proposal and estimate for guaranteed dry basement repairs.

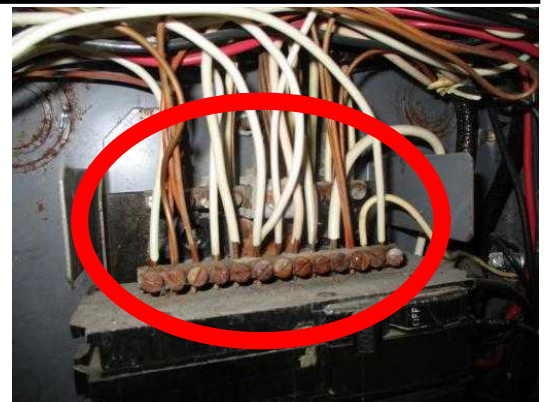
- 10. Dwelling Electrical Panel Enclosure:** Multiple conductors had been installed within single terminals on neutral / ground bus bars (double tapped) within the electrical panel. While this was not an uncommon practice in the past, installation of multiple conductors per lug where the neutrals are secured can result in a loose connection which is a safety concern. Installation of only one neutral conductor per lug terminal is recommended for safety. Recommend servicing be completed by a licensed electrician.

The electrical circuits were not labeled. Recommend all circuits be accurately labeled for easy identification and safety.

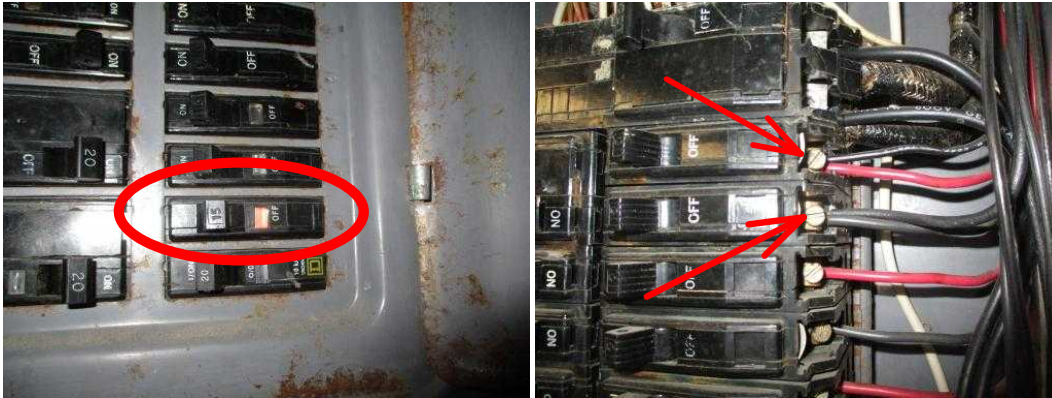
- 11. Dwelling Electrical Panel Breakers:** One of the electrical circuits in the panel was tripped at the time of the inspection. No attempt was made to reset this circuit. Recommend repairs be completed to correct the condition that caused the circuit to trip, and proper operation verified.
- There were 2 wires attached to two of the single pole breaker terminals within this electrical panel. Installation of more than one wire per terminal can result in a loose wire connection, improper electrical performance, over heating and considered a safety issue. Recommend a licensed electrician complete repairs to correct this condition for improved safety.

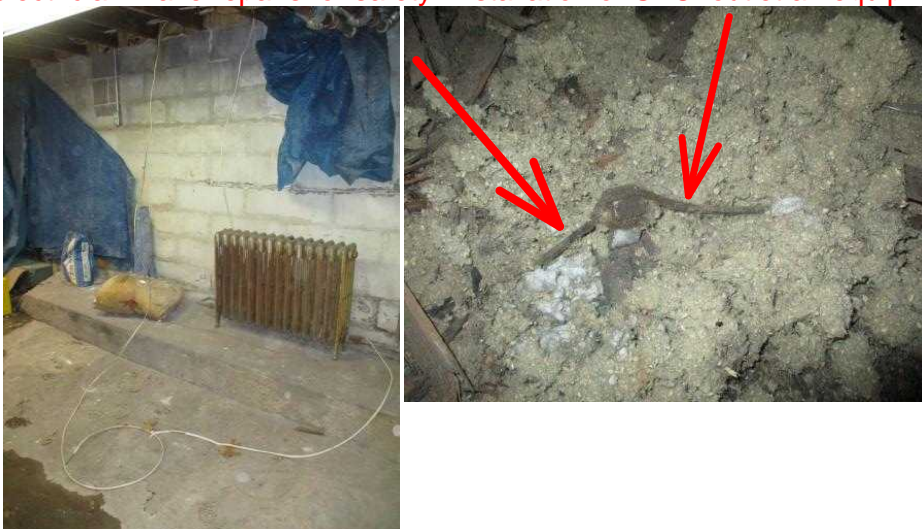
- 12. Visible Branch Circuits (outlets, switches, wiring, etc.):** Unprotected and unsecured electrical cables were noted lying on the floor at the South side of the basement. Recommend the ends of cables be protected and enclosed in covered junction boxes for safety.

Live knob and tube wiring was noted directly South of the attic access and covered by installation and therefore rated non functional as a potential fire / safety hazard. Recommend knob and tube wiring be replaced by a licensed electrician for safety.

The outlet at the SW corner of the 1st floor living room tested reverse polarity (hot/neutral wires reversed) and rated non functional as a safety hazard. Recommend a licensed electrician properly install this outlet for safety.

A 3 prong outlet tested ungrounded at the NW corner of the dining room. Recommend a licensed electrician make repairs for safety. Installation of GFCI outlet an equipment ground are options.

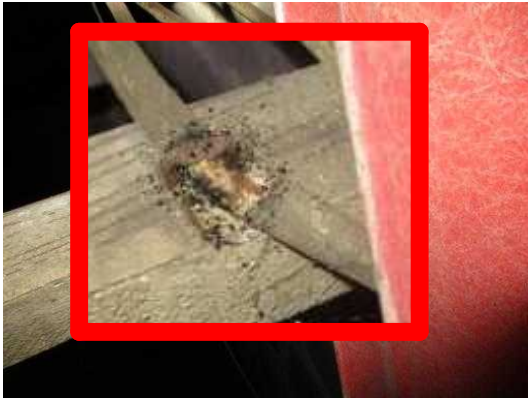
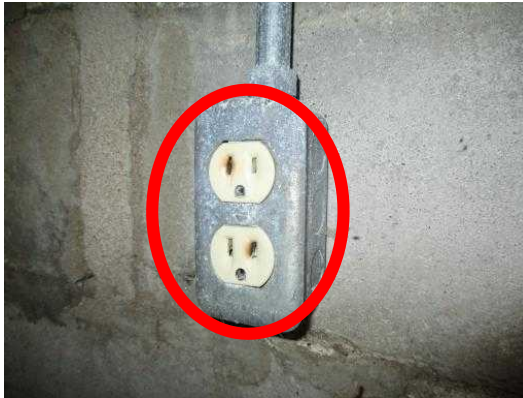
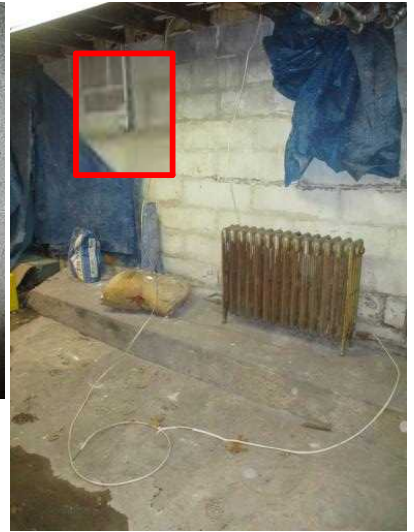
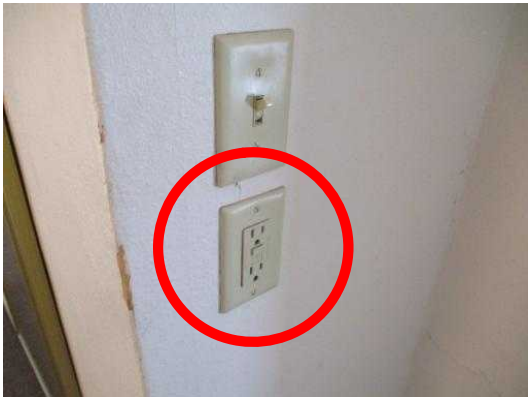
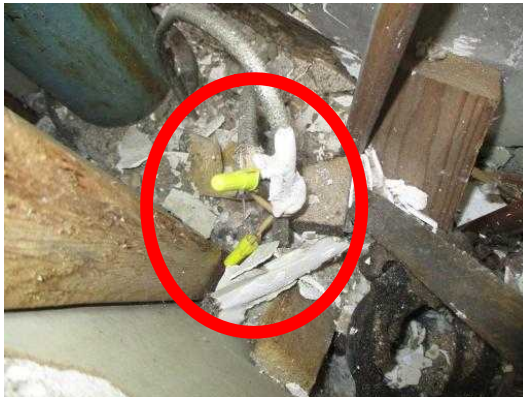
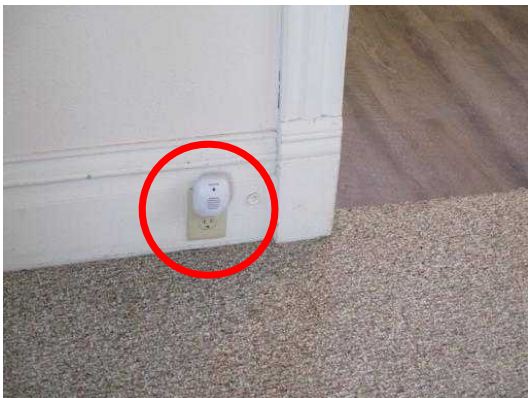
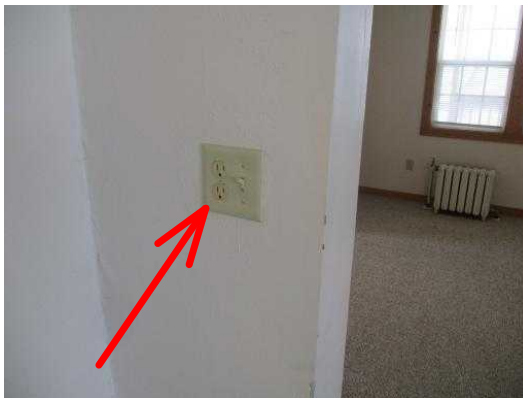
The cloth sheathing was damaged on an electrical cable where the ladder was being used to get from the 1st floor to basement. Recommend the damaged cable be repaired / replaced by a licensed electrician

Burn marks were noted at an outlet near the laundry appliance. This outlet, and one at the basement's South central wall also did not have power during the inspection. Recommend repairs be completed by a licensed electrician and proper / safe electrical circuit operation be verified.

Power was not disconnected from the GFCI outlet at the 2nd floor hallway when tested. This may be due to improper installation of the outlet (i.e. line / load reversed). Recommend a licensed electrician make repairs to correct this condition and ensure the outlet is properly GFCI protected.

An unprotected electrical connection was noted in the wall opening North of the kitchen countertop. Recommend electrical connection be properly secured and protection inside of covered junction boxes for safety.

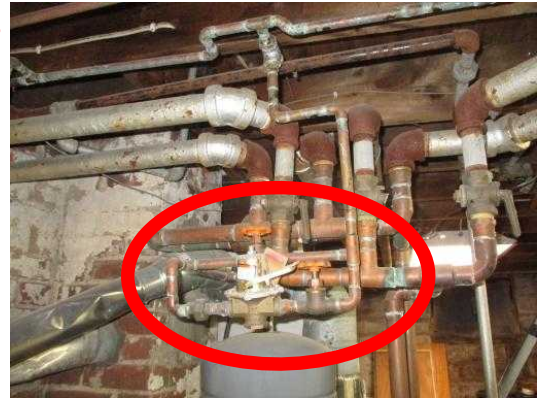
- 13. Dwelling Hot Water Boiler** No visible back flow prevention device was noted in place between the dwelling's domestic water supply and the hot water boiler system. While the lack of backflow prevention is not uncommon in older systems and or in some locations, it is recommended to prevent potential cross connection for health and safety. Backflow requirements can vary between locations. For any further information, recommend consult the local authority having jurisdiction or the water supply utility company. General recommendations are for a licensed plumber to install a backflow prevention device for health / safety.

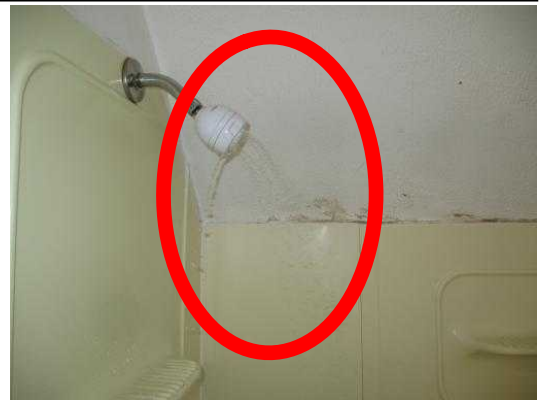
- 14. Water Pressure / Flow** Very poor water pressure was noted from the 2nd floor bathroom shower when multiple plumbing fixtures were operated simultaneously (especially flushing the toilet). Recommend further evaluation be completed by a licensed plumber to obtain a proposal for corrective measures.

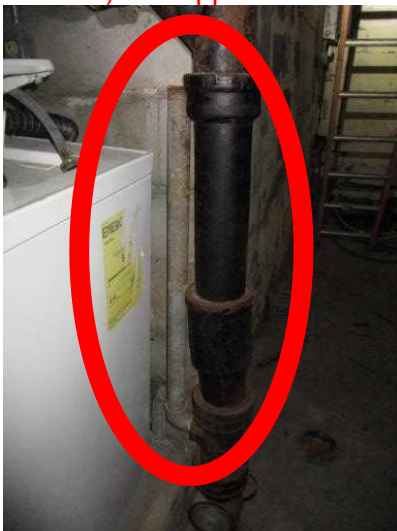
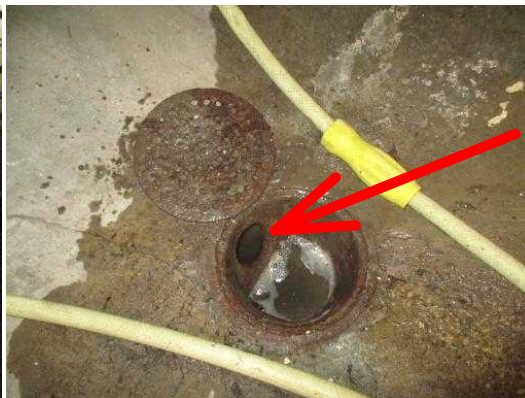
- 15. Drain / Vent Plumbing:** There was no trap in the stand pipe drain near the laundry appliances. Recommend a trapped stand pipe be installed by a licensed plumber to prevent the escape of unhealthy sewer gases.

The clean out cap had been removed from the basement floor drain. Removing this cap bypasses that drain trap and can allow the escape of harmful sewer gases and rated non functional. Recommend a licensed plumber or qualified drain cleaning contractor service / repair, re-install the clean out cover, and verify the floor drain is functioning properly.

Recommend the open ends of the drain pipe(s) (where disconnected when the rear addition was removed) be capped while not in use.

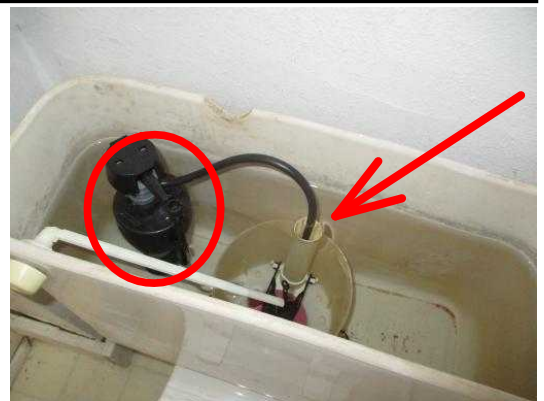
16. **2nd Floor Bathroom Toilet:** The toilet was loose and the tank refill ran on beyond the overflow. Recommend repairs be completed by a licensed plumber and leak free and proper flush / fill operation verified.

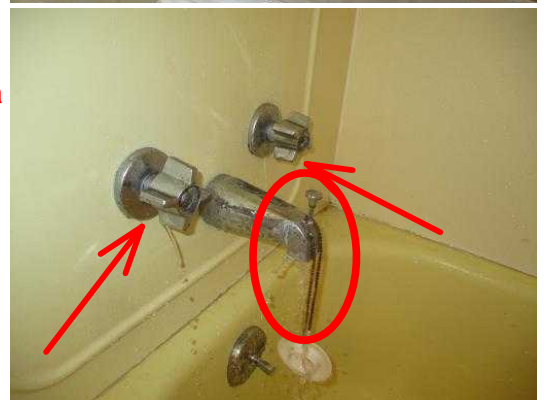
17. **2nd Floor Bathroom Shower:** Leakage was noted from the hot and cold water supply valves when the shower was operating. The diverter valve was also stuck and leaking. Recommend repairs be completed by a licensed plumber and leak free valve and proper diverter operation verified.

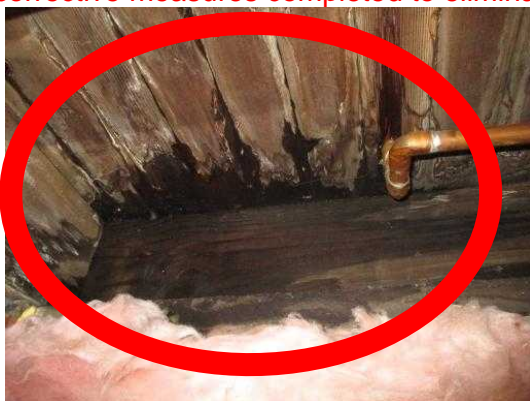
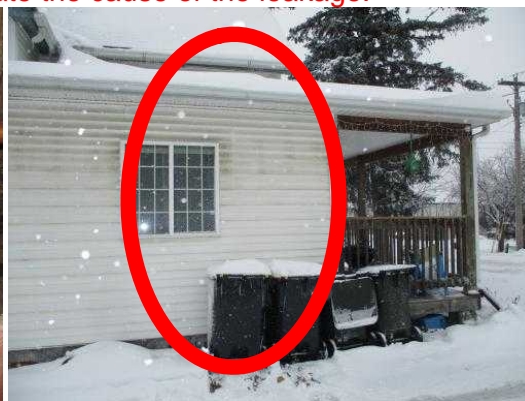
18. **Evidence of Water Infiltration:** The subfloor was wet as viewed from the NE corner of the basement, at the area below and just North of the hydronic baseboard unit. No obvious sources of leakage could be identified. It is possible that an ice dam or other roofing issue exists and leakage is traveling down the wall cavity and showing up on the floor of the NE room. Recommend further investigation be completed by a qualified contractor to identify the source of leakage and repairs completed. Recommend any moisture damaged components be replaced and corrective measures completed to eliminate the cause of the leakage.

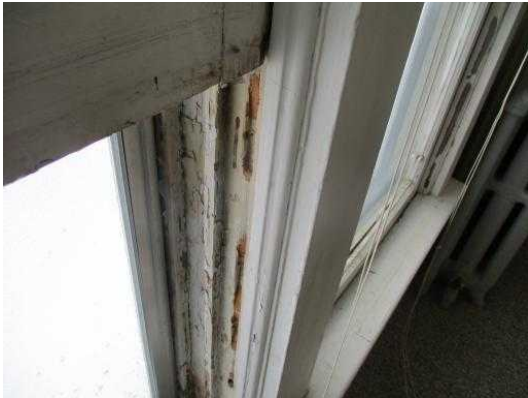
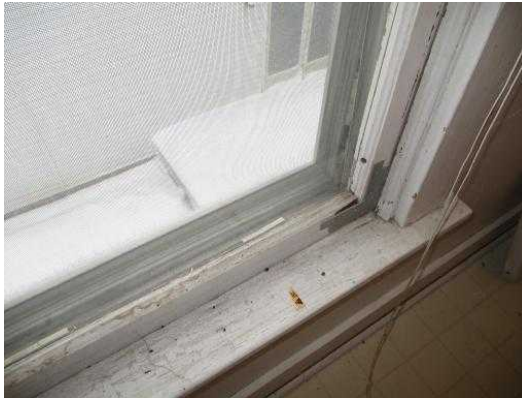
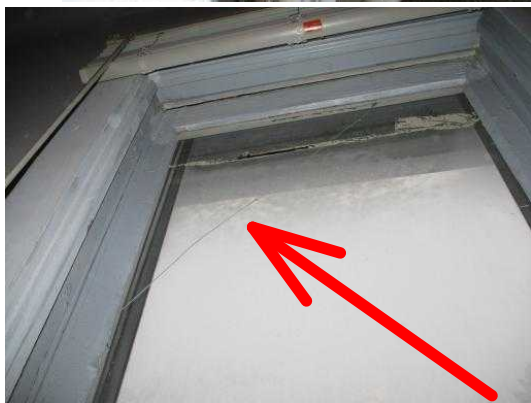
19. **Interior Windows (Primary):** Double Hung The older wooden windows were in poor condition. The majority of the sash were not supported, and appeared to have been secured using pegs in the past. The jambs were worn and the pegs were not a reliable way to secure the windows during the inspection. Recommend repairs be completed by a qualified contractor to provide proper and safe window operation. Based on their age and condition, replacement of the the older wooden window is recommended.

Cracked window panes were noted at the 2nd floor stairway. Recommend cracked glass panes be replaced for proper weather protection and safety.

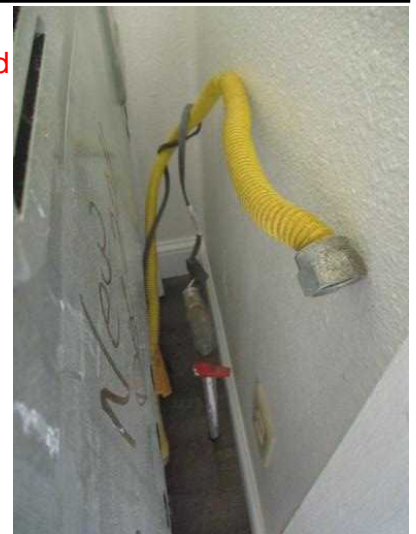
- 20. Kitchen Range: Gas** The kitchen range was not installed / connected and could not be operated at the time of the inspection. Recommend installation be completed and proper operation verified. General recommendations are to cap the gas line while the appliance is not connected / actively used, for safety.

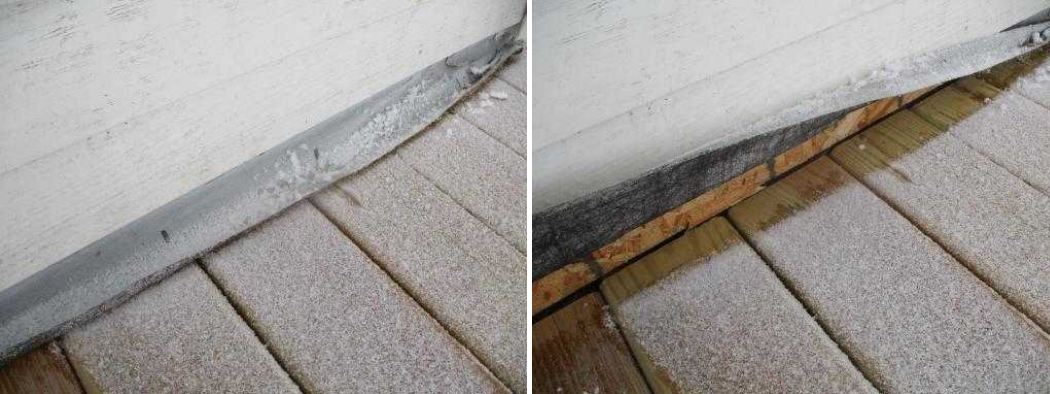
1. **Flashing:** The weather resistant barrier extended out from the bottom of the siding and overtop of the porch floor. Recommend permanent flashing be installed where the floor structure of the porch is attached to the house. All components should be installed in a shingle fashion extending back to the exterior.

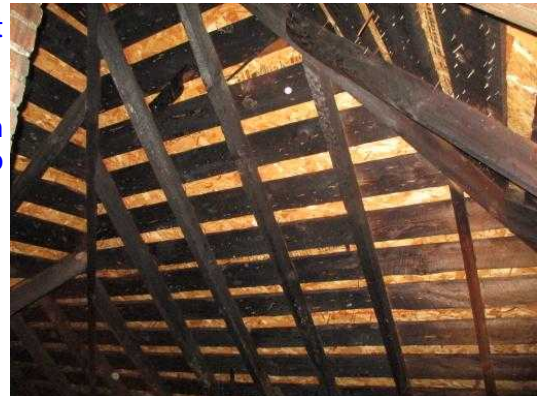
2. **Dwelling Attic Visible Roof Structure:** Rafter Fire damage was noted at the older visible roof structure at the South side of the attic. Structural evaluation of fire damaged components is beyond the scope of this inspection. No structural repairs or bracing had been installed. Installation of sister rafters alongside of the damaged rafters should be considered to help ensure structural integrity. For further evaluation and or to obtain a proposal and estimate of cost, recommend consult a qualified carpenter / contractor.

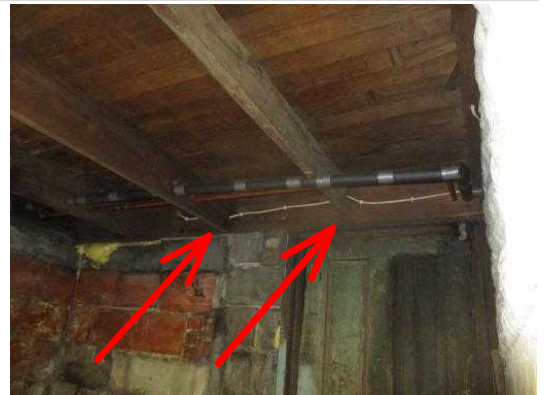
3. **Floor Joists:** Recommend joist hangers be installed at the South end of the floor joists in the basement's NE room.
